Debris/Ice/TPS Assessment and Integrated Photographic Analysis of Shuttle Mission STS-72

**DEBRIS/ICE/TPS ASSESSMENT
AND
INTEGRATED PHOTOGRAPHIC ANALYSIS
OF
SHUTTLE MISSION STS-72**

11 January 1996

**NASA, Lockheed-Martin, Rockwell, and Thiokol Members of the
Debris/Ice/TPS and Photographic Analysis Teams**

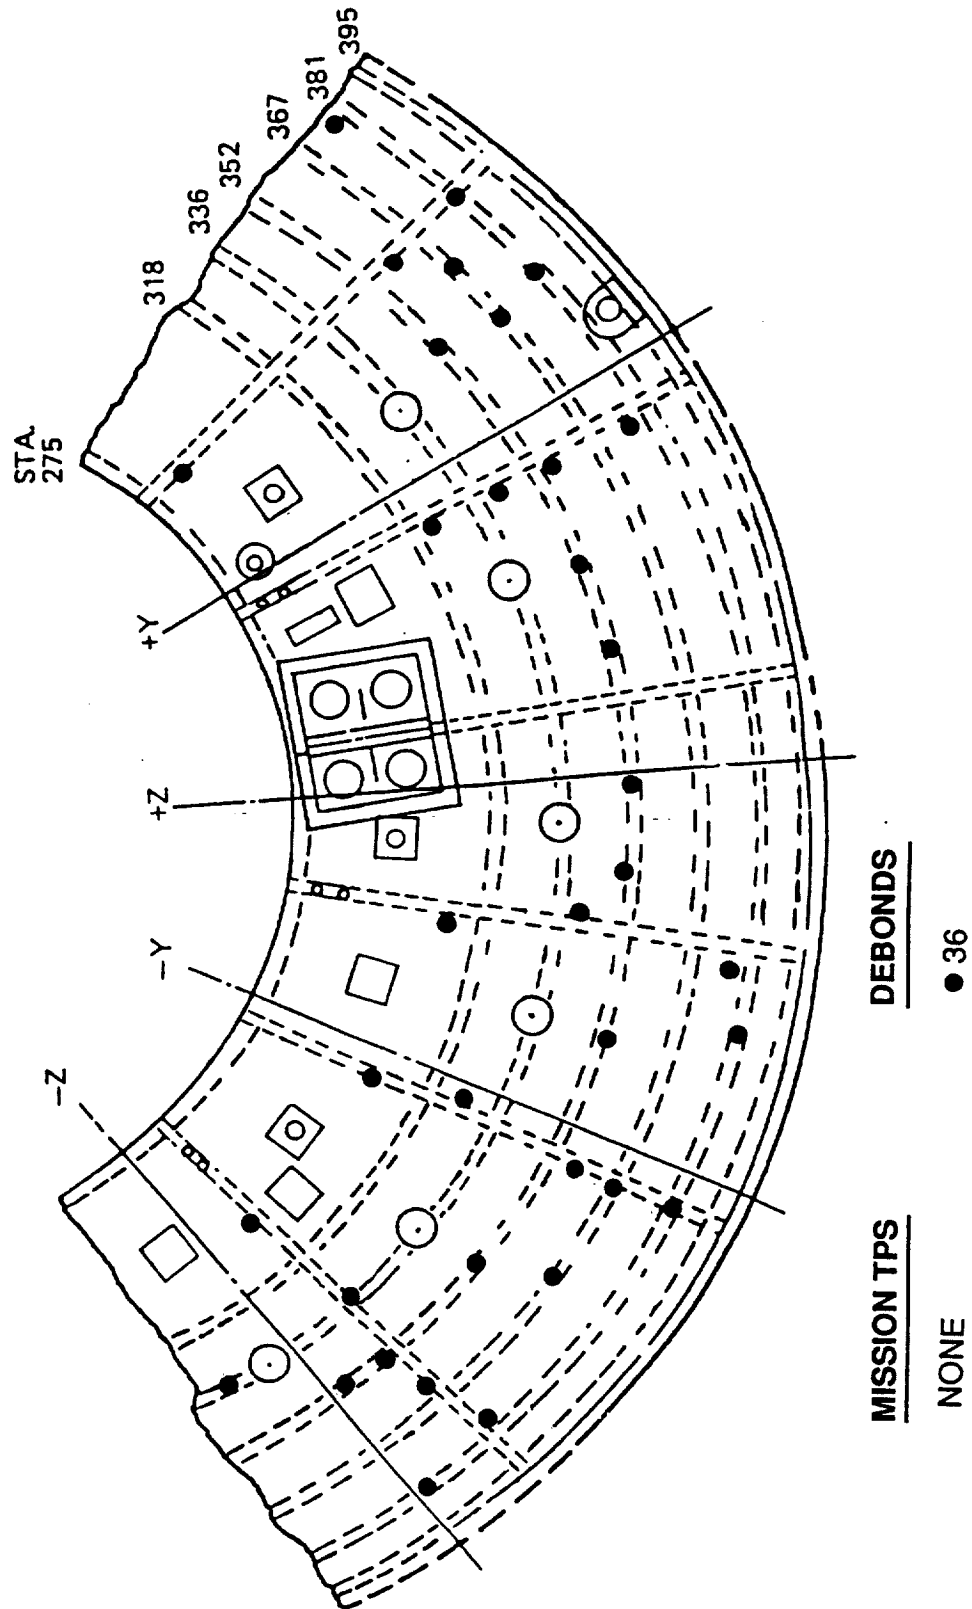
Figure 5: LH SRB Frustum

The LH frustum was missing no TPS. The number of MSA-2 debonds over fasteners (36) was average (Figure 5). Hypalon paint was blistered/missing along the XB-395 ring frame where BTA closeouts had been applied. However, most of the exposed BTA substrate was not sooted. The BSM aero heat shield covers had locked in the fully opened position.

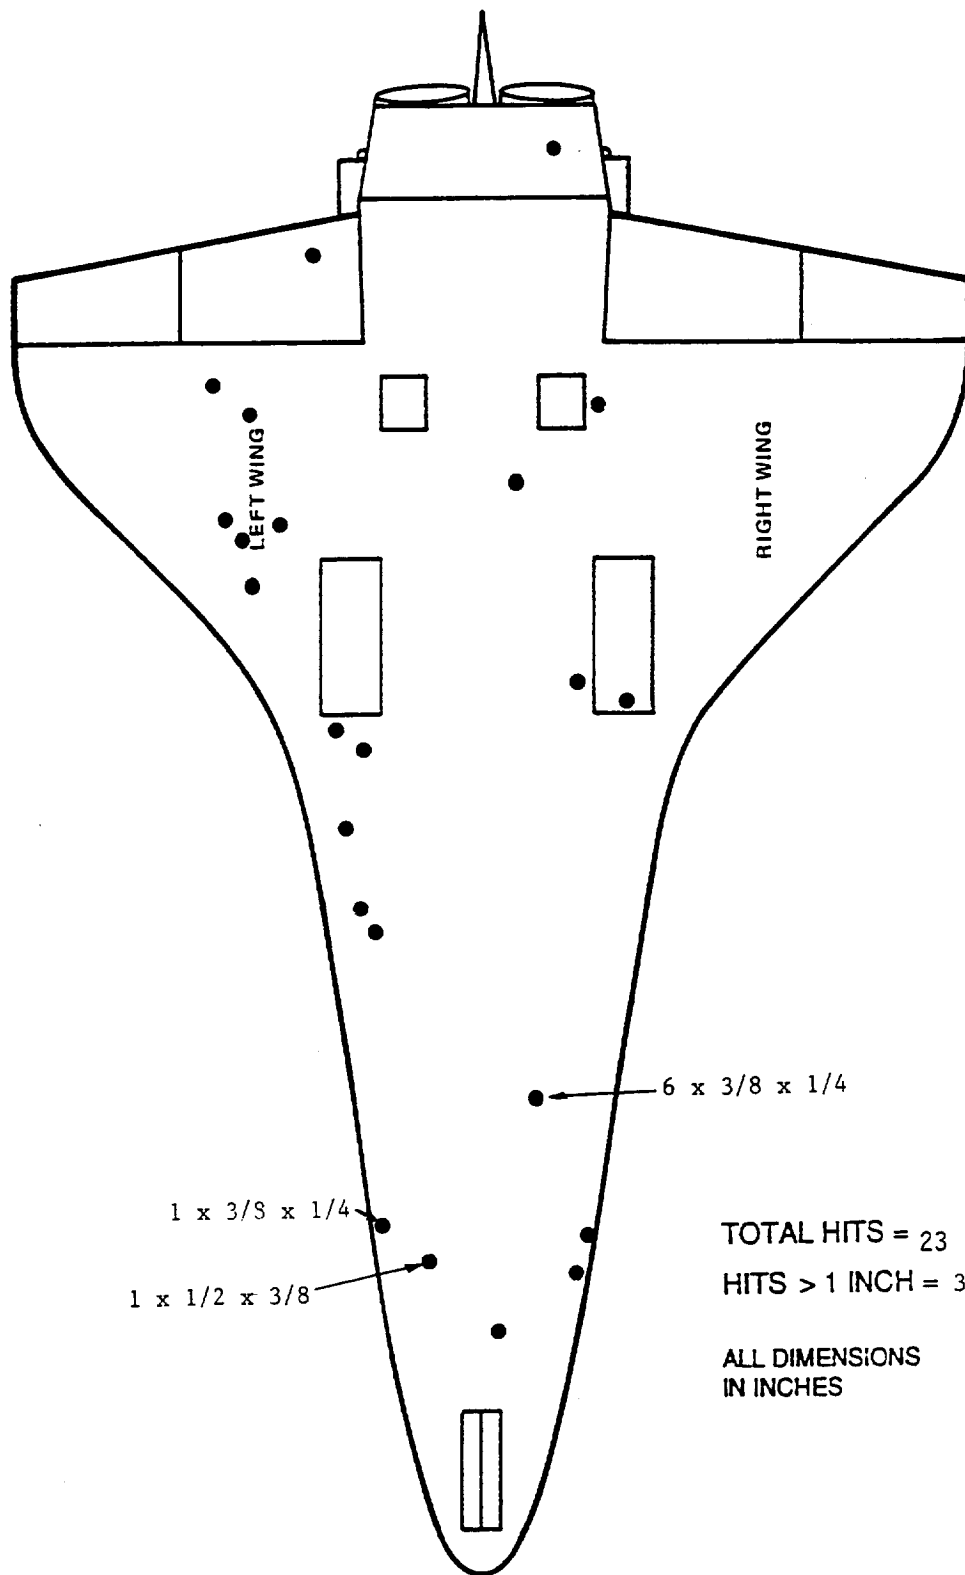
Figure 6: Orbiter Lower Surface Debris Map

The Orbiter lower surface sustained a total of 23 hits, of which 3 had a major dimension of 1-inch or larger. The largest lower surface tile damage site occurred approximately 15 feet forward of the RH MLG wheel well and measured 6.0-inches long by 0.375-inches wide by 0.25-inch maximum depth. The only debris found on the runway under the umbilical cavities (LH2) consisted of a bolt 0.875-inches long by 0.1875-inches in diameter with a red coating on the head. The bolt, stamped with the number MS 21279-7, is used in the Orbiter aft compartment SSME wire bundle clamps. A post flight inspection of the aft revealed no missing bolts (Ref. Lost and Found PR LAF-5-11-0199).

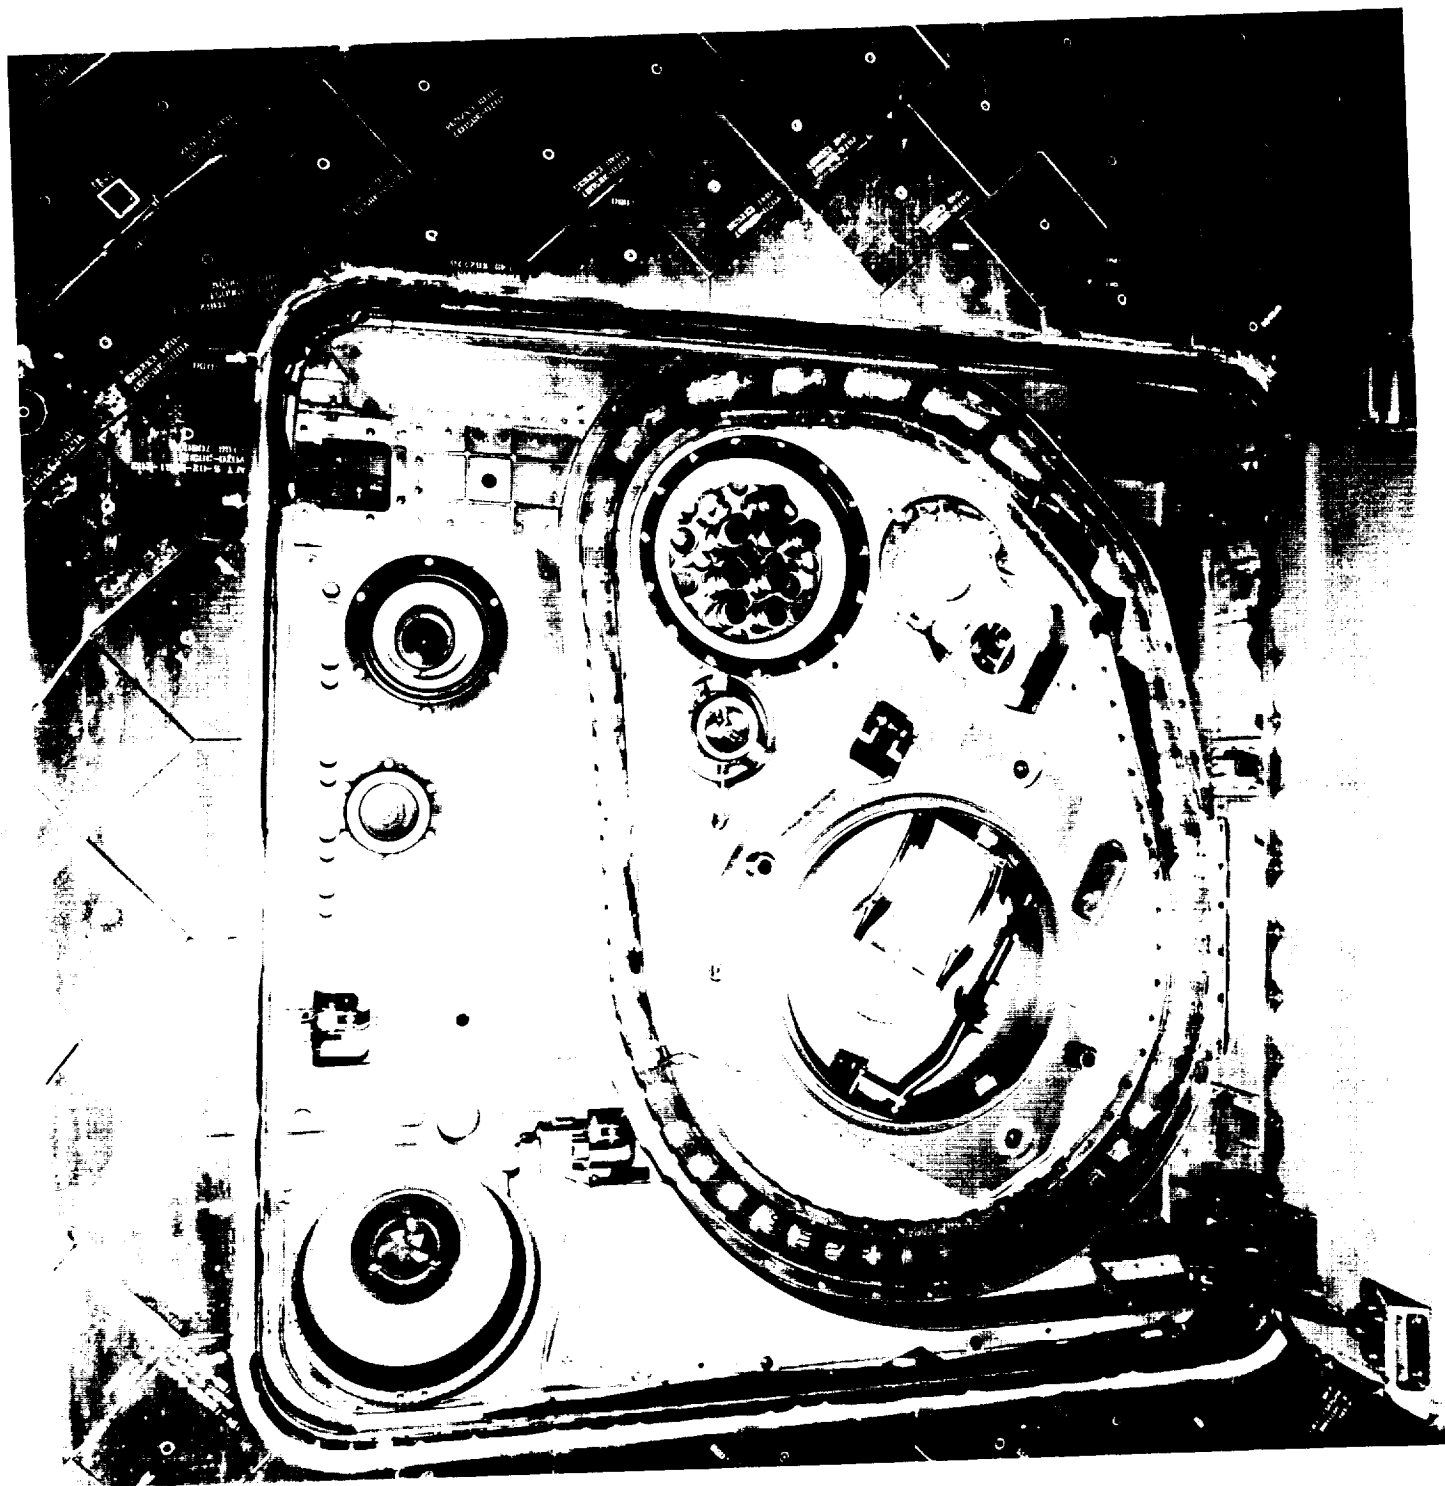
Photo 26: LH2 ET/ORB Umbilical

Orbiter umbilical camera films showed nominal separation of SRB's from the External Tank and normal separation of the ET from the Orbiter. The LH2 ET/ORB umbilical appeared to be in good condition with little or no TPS damage. Foam was missing or eroded from the horizontal (clamshell) section of the cable tray and the aft surface of the -Y vertical strut. Pieces of charred foam impacted the LH SRB aft booster and broke into smaller pieces.

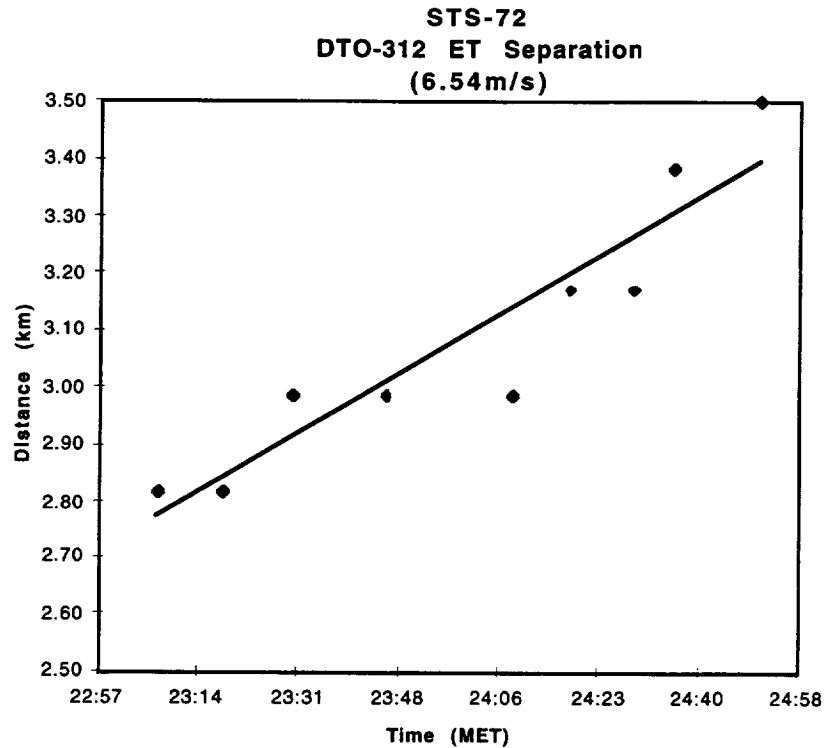
Figure 2.4.1(A) ET Separation Velocity.

Using the 35mm handheld (Nikon F4) camera film, the external tank distance was calculated over a 9 frame sequence. The external tank was calculated to be a distance of 2.8km away from the Orbiter at 23:07 MET; 104 seconds later at 24:51 MET the tank was calculated to be at 3.5km. The tank separation velocity was determined to be 6.54 m/s. Roll rate was estimated at 0.6°/sec, and tumble rate was estimated at 0.4°/sec. The separation velocity and roll/tumble rates were similar to previous mission measurements.
